SB-957

SERVICE BULLETIN AMATEUR RADIO

SUBJECT	DATE
TH-75A NO TX ON VHF USING A VEHICLE BATTERY SUPPLY	01/09/90

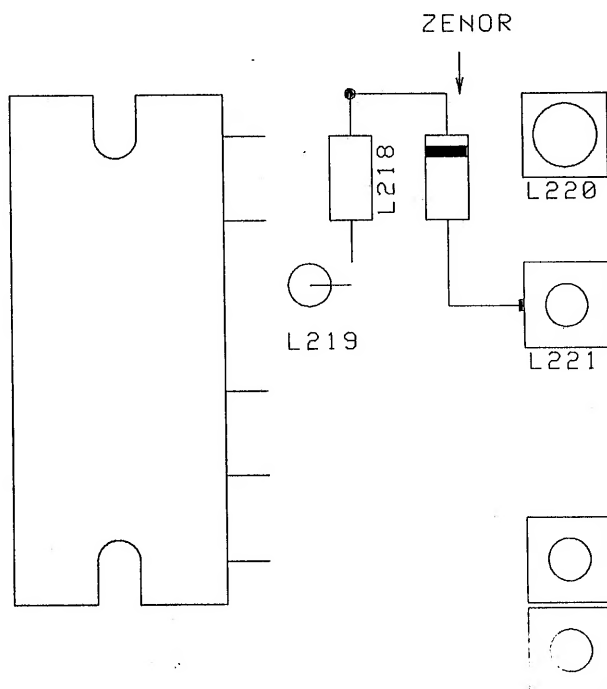
When the TH-75A is connected to a vehicle battery, ignition or alternator noise can be induced on the DC line. When the transceiver is in the automatic battery saver mode, the noise pulses overcharge C348 on the RF board causing it to short. The supply current opens L218 and the foil trace at this coil. To protect the transceiver, a Zener diode will be used to clamp the SBR line.

The Zener should be soldered between the SBR side of L218 and the shielding case of L221 on the component side of the RF board (X53-3370-11) (A/3). The Service Manual disassembly instructions will be required to perform this modification.

REQUIRED PART: 22V ZENER DIODE - KENWOOD PART # UZP-22B
